**Flood Control Project Maintenance  
Levee Inspections**

## Maintenance Issue Types Only, Levee Inspection Report By Mile - Spring 2015

### Sacramento Maintenance Yard West Levee Yolo Bypass

Waterway	Bank	Unit Miles	Inspection Start/End	Inspector
Unit No. 01 West Levee	Right	2.73	04/15/2015 04/15/2015	Jai Lor

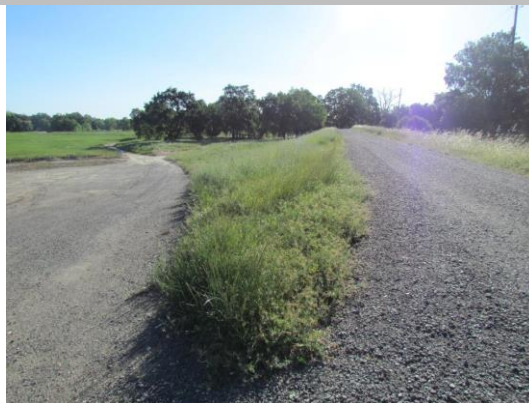
Photo 1 of 1 : SP\_2015\_ST0011\_291\_3\_20150415\_00008.jpg

LM Start	0.01	Rating **	M	Issue No.	3
LM End	2.72	Issue Type +	Ma	Location *	WS
Category	Earthen Levee			GPS Latitude/Longitude	
				Start	End
Item	Vegetation			38.759035 °	38.724252 °
				-121.667447 °	-121.665222 °
DWR ID	DWR_ST0011_01_s _ 2015_3				
Action/Comments					
Control annual grass and weeds on the levee slopes and easements.

View of the vegetation on the waterward side of the levee looking downstream. Spring 2015.

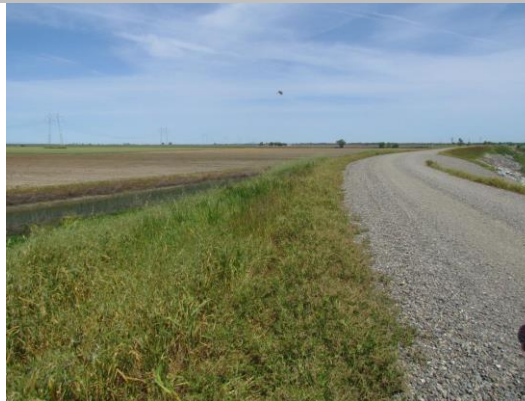
Photo 1 of 1 : SP\_2015\_ST0011\_292\_4\_20150413\_00003.jpg

LM Start	0.00	Rating **	M	Issue No.	4
LM End	1.46	Issue Type +	Ma	Location *	LS
Category	Earthen Levee			GPS Latitude/Longitude	
				Start	End
Item	Vegetation			38.719240 °	38.699470 °
				-121.664235 °	-121.674132 °
DWR ID	DWR_ST0011_02_s _ 2015_4				
Action/Comments					
Control annual grass and weeds on the levee slopes and easements.

View of vegetation on the landward side of the levee looking upstream.  
Spring 2015.

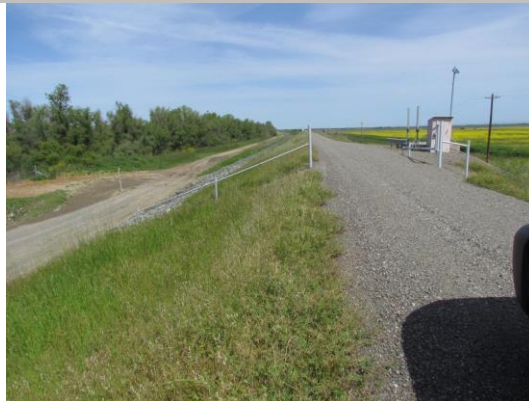
Photo 1 of 1 : SP\_2015\_ST0011\_293\_3\_20150413\_00001.jpg

LM Start	0.00	Rating **	M	Issue No.	3
LM End	1.41	Issue Type +	Ma	Location *	LS
Category	Earthen Levee			GPS Latitude/Longitude	
				Start	End
Item	Vegetation			38.698643 °	38.678248 °
				-121.674152 °	-121.672982 °
DWR ID	DWR_ST0011_03_s_2015_3				
Action/Comments					
Control annual grass and weeds on the levee slopes and easements.

View of vegetation on the landward side of the levee looking upstream.  
Spring 2015.

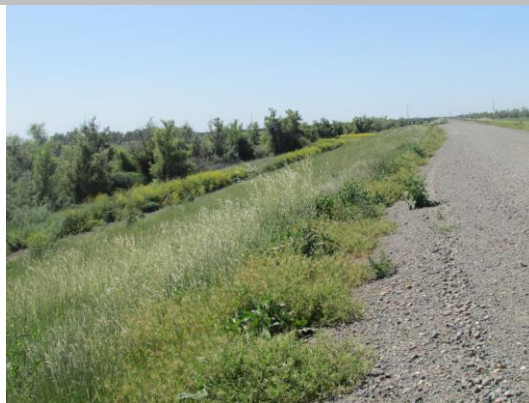
Photo 1 of 1 : SP\_2015\_ST0011\_294\_1\_20150421\_00007.jpg

LM Start	0.00	Rating **	M	Issue No.	1
LM End	3.63	Issue Type +	Ma	Location *	WS
Category	Earthen Levee			GPS Latitude/Longitude	
				Start	End
Item	Vegetation			38.574345 °	38.523421 °
				-121.638753 °	-121.631464 °
DWR ID	DWR_ST0011_04_s_2015_1				
Action/Comments					
Control annual grass and weeds on the levee slopes and easements.

View of the vegetation on the water ward side of the levee looking downstream. Spring 2015.

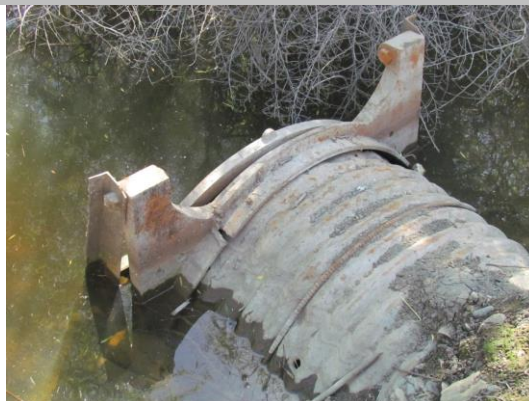
Photo 1 of 2 : SP\_2015\_ST0011\_294\_2\_20150421\_00008.jpg

LM Start	0.78	Rating **	M	Issue No.	2
LM End	0.78	Issue Type +	Ma	Location *	WS
Category	Structures & Concrete Lined Channels			GPS Latitude/Longitude	
				Start	End
Item	Flap Gates			38.563163 °	38.563163 °
				-121.637994 °	-121.637994 °
DWR ID	DWR_ST0011_04_s_2015_2				
Action/Comments

View of the flap gate in the ditch on the water side of the levee. The flap gate seems to be broken and there are holes on the pipe. Spring 2015.

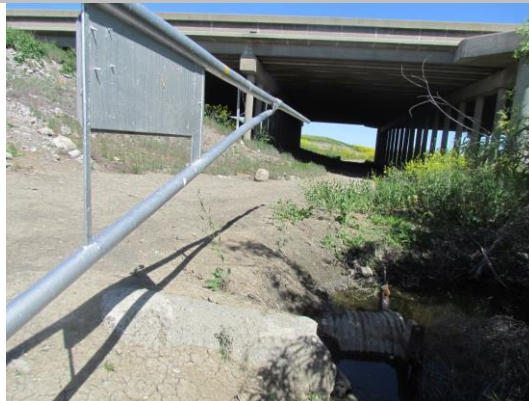
Photo 2 of 2 : SP\_2015\_ST0011\_294\_2\_20150421\_00009.jpg

LM Start	0.78	Rating **	M	Issue No.	2 (cont)	
LM End	0.78	Issue Type +	Ma	Location *	WS	
Category	Structures & Concrete Lined Channels			GPS Latitude/Longitude		
				Start		End
Item	Flap Gates			38.563163 °		38.563163 °
				-121.637994 °		-121.637994 °
DWR ID	DWR_ST0011_04_s _ 2015_2					
Action/Comments

View of a perspective on the pipe looking upstream. Spring 2015.
